**MARIN COUNTY STREAM CROSSING INVENTORY AND FISH PASSAGE
EVALUATION**

FINAL REPORT

Prepared for the County of Marin – Department of Public Works

Ross Taylor and Associates

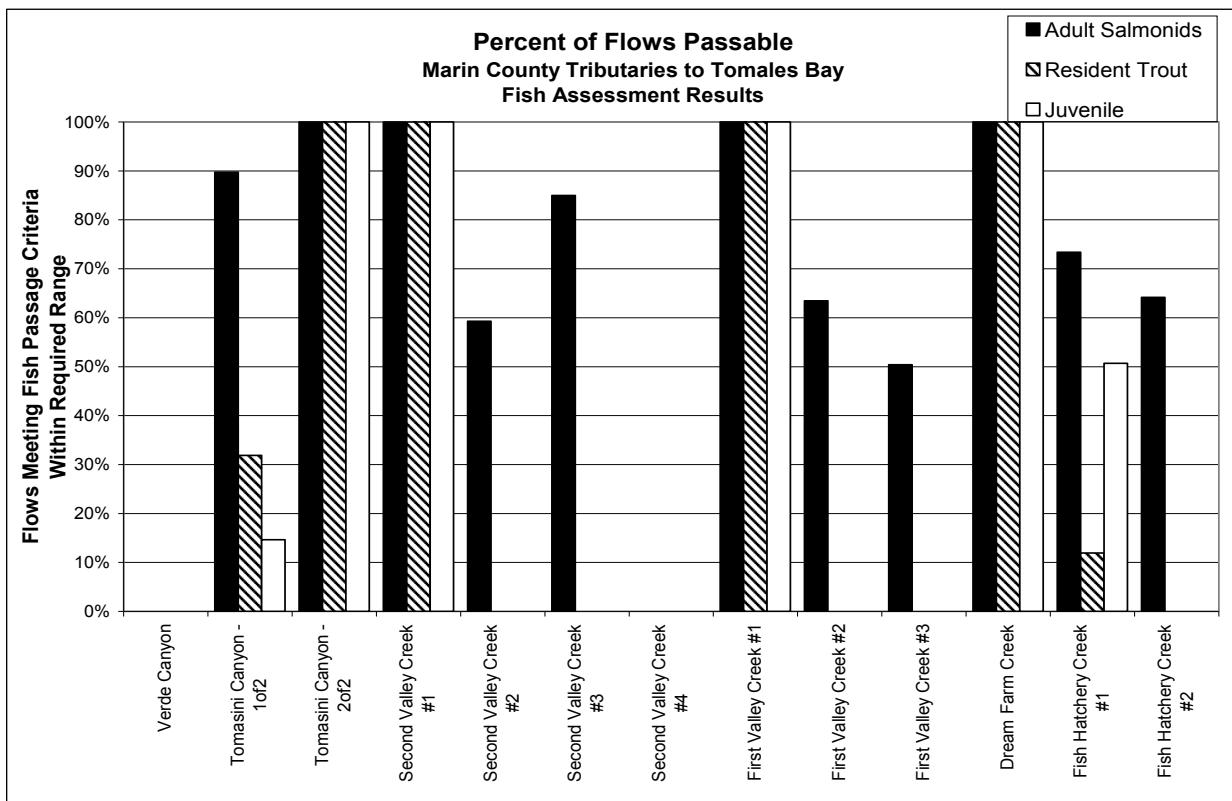
Figure 7. Percent passable as estimated by the Green-Gray-Red evaluation filter and FishXing for 12 Marin County stream crossings within tributaries of the Tomales Bay sub-watershed, by three groups of life stages.

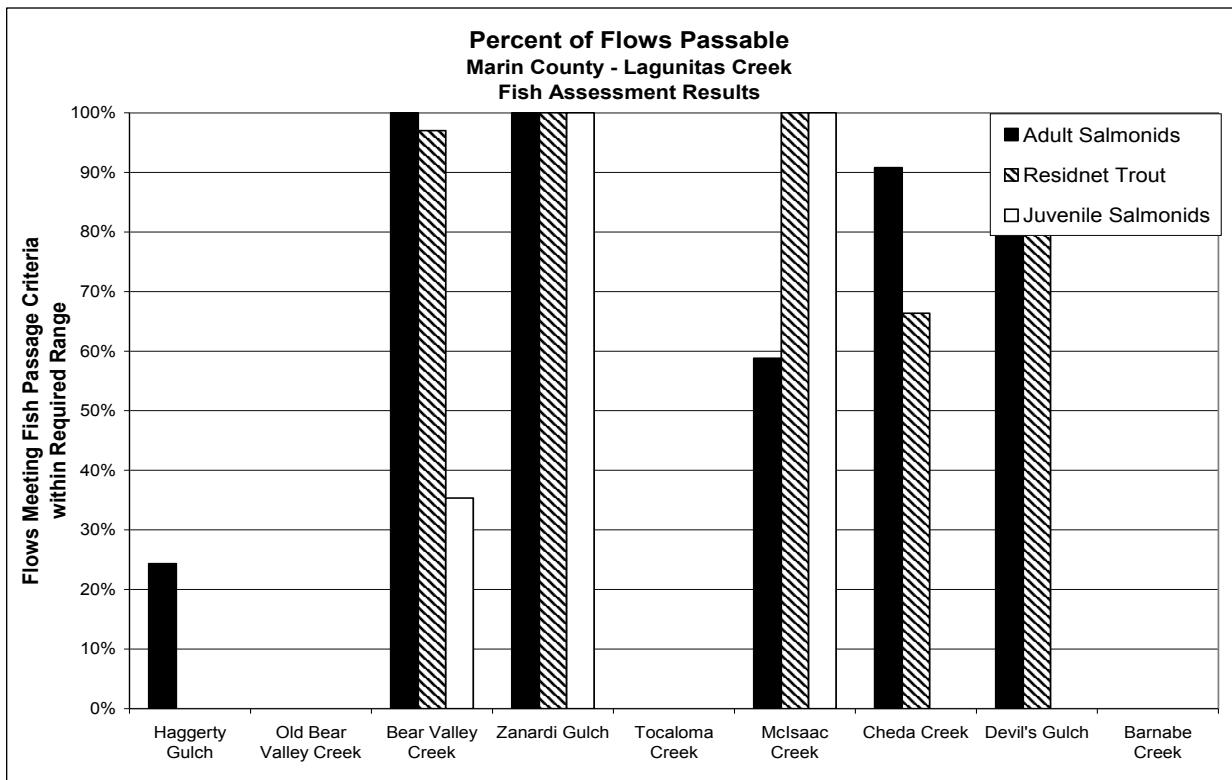
Figure 8. Percent passable as estimated by the Green-Gray-Red evaluation filter and FishXing for nine Marin County stream crossings within tributaries of Lagunitas Creek, by three groups of life stages.

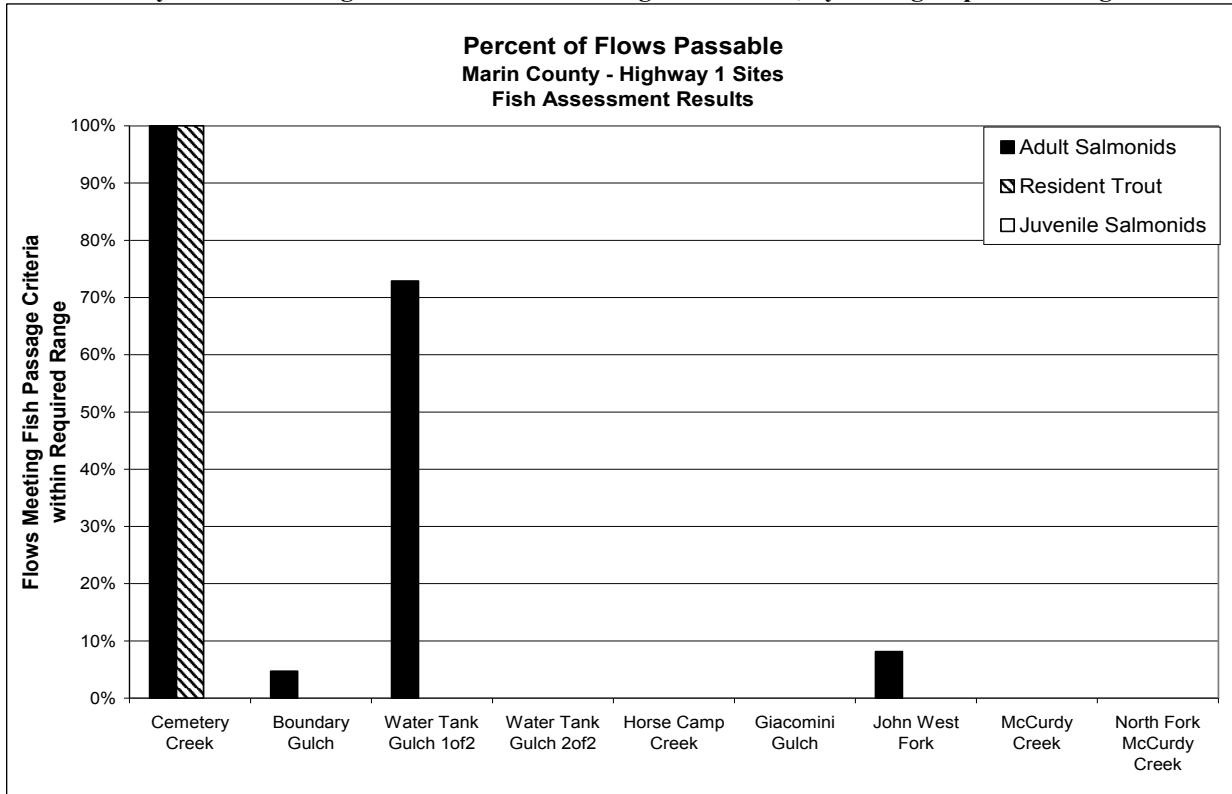
Figure 9. Percent passable as estimated by FishXing for eight Marin County stream crossings located on Highway One on tributaries to Olema Creek and Pine Creek, by three groups of life stages.

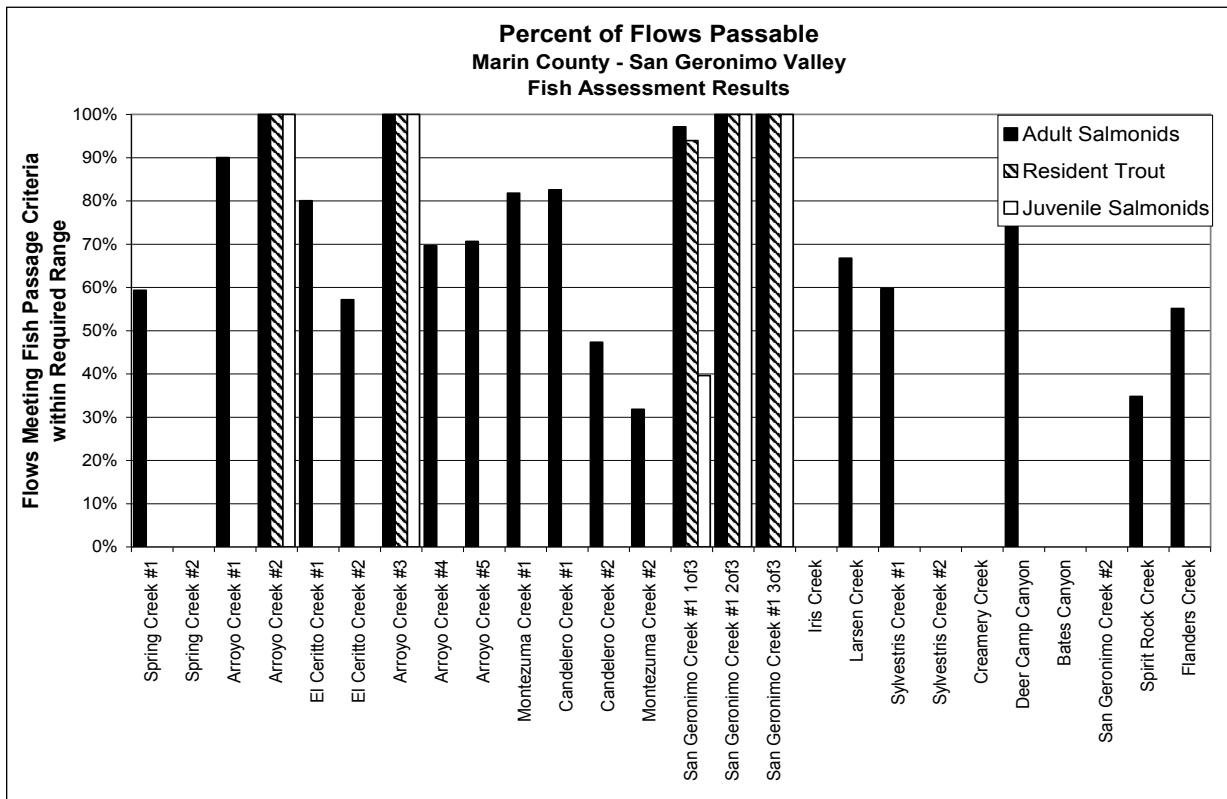
Figure 10. Percent passable as estimated by FishXing for 24 Marin County stream crossings within the San Geronimo sub-basin of the Lagunitas Creek watershed, by three groups of life stages.

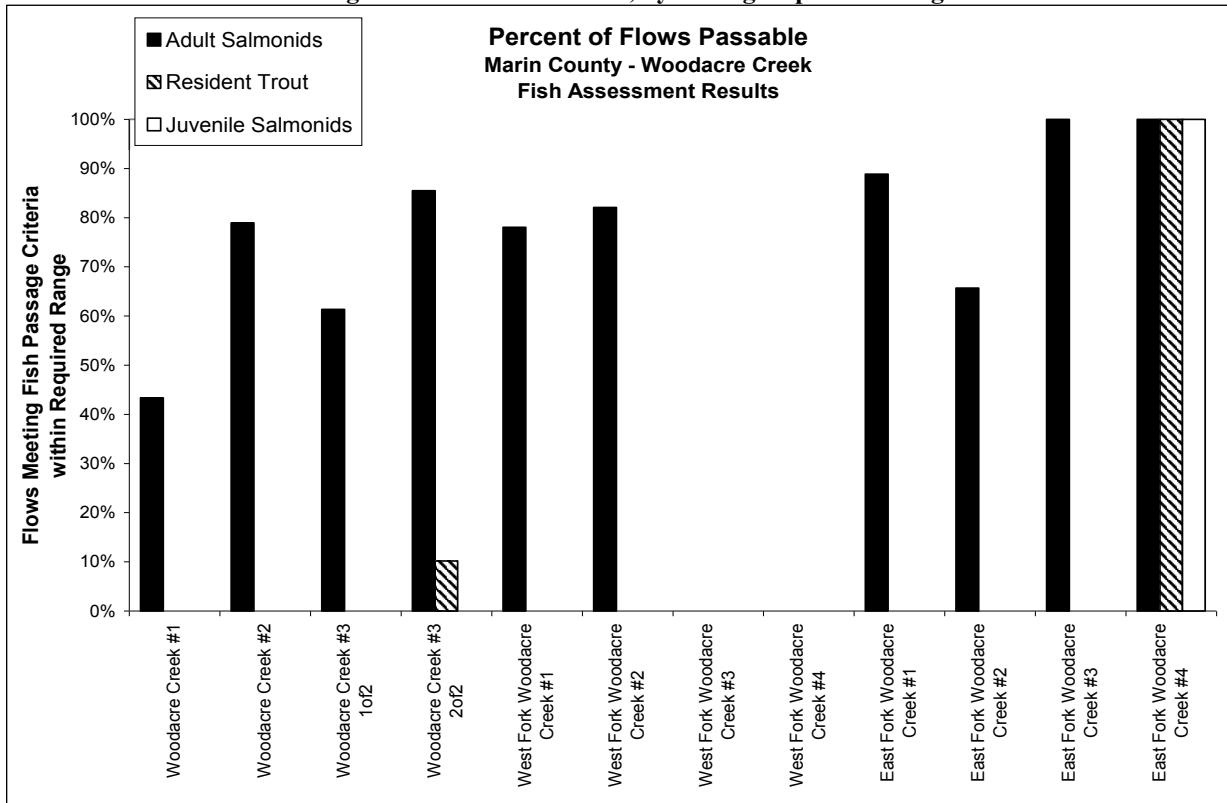
Figure 11. Percent passable as estimated by FishXing for 11 Marin County stream crossings within the Woodacre Creek sub-basin of the Lagunitas Creek watershed, by three groups of life stages.

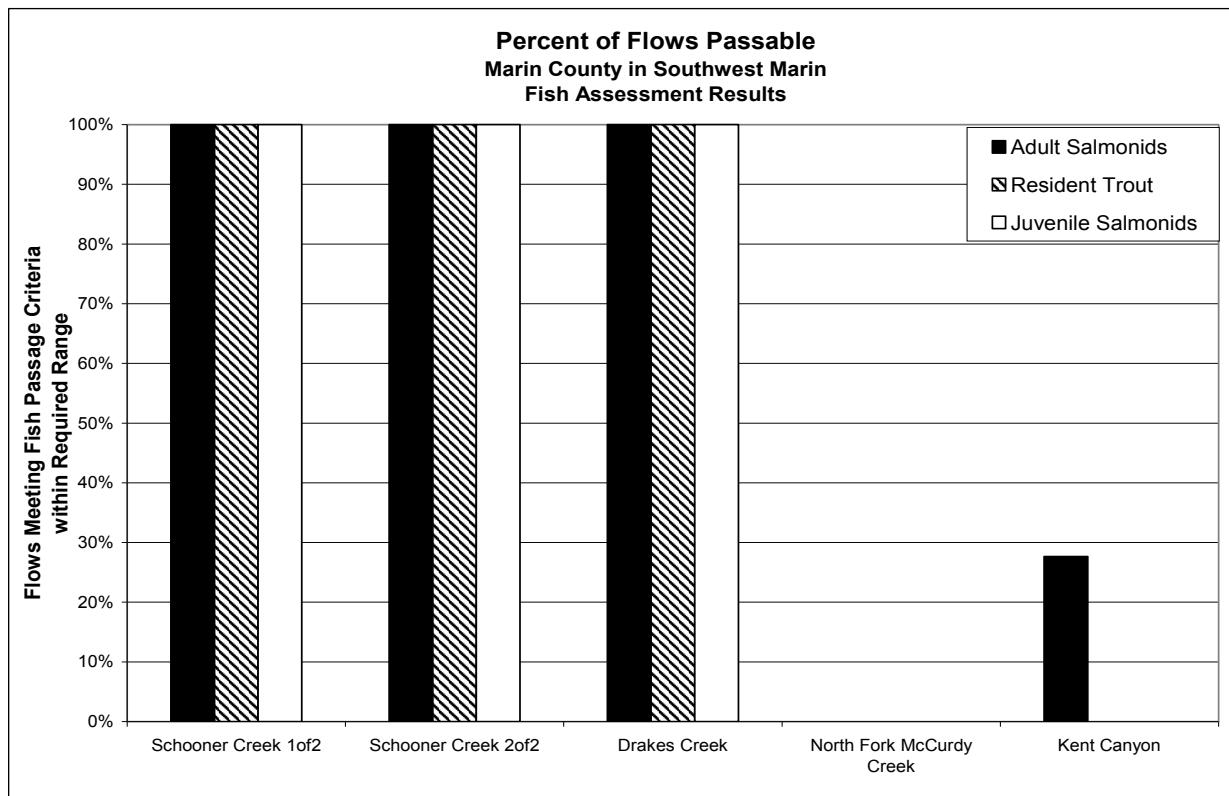
Figure 12. Percent passable as estimated by FishXing for four Marin County stream crossings on tributaries located in southwestern Marin County, by three groups of life stages.

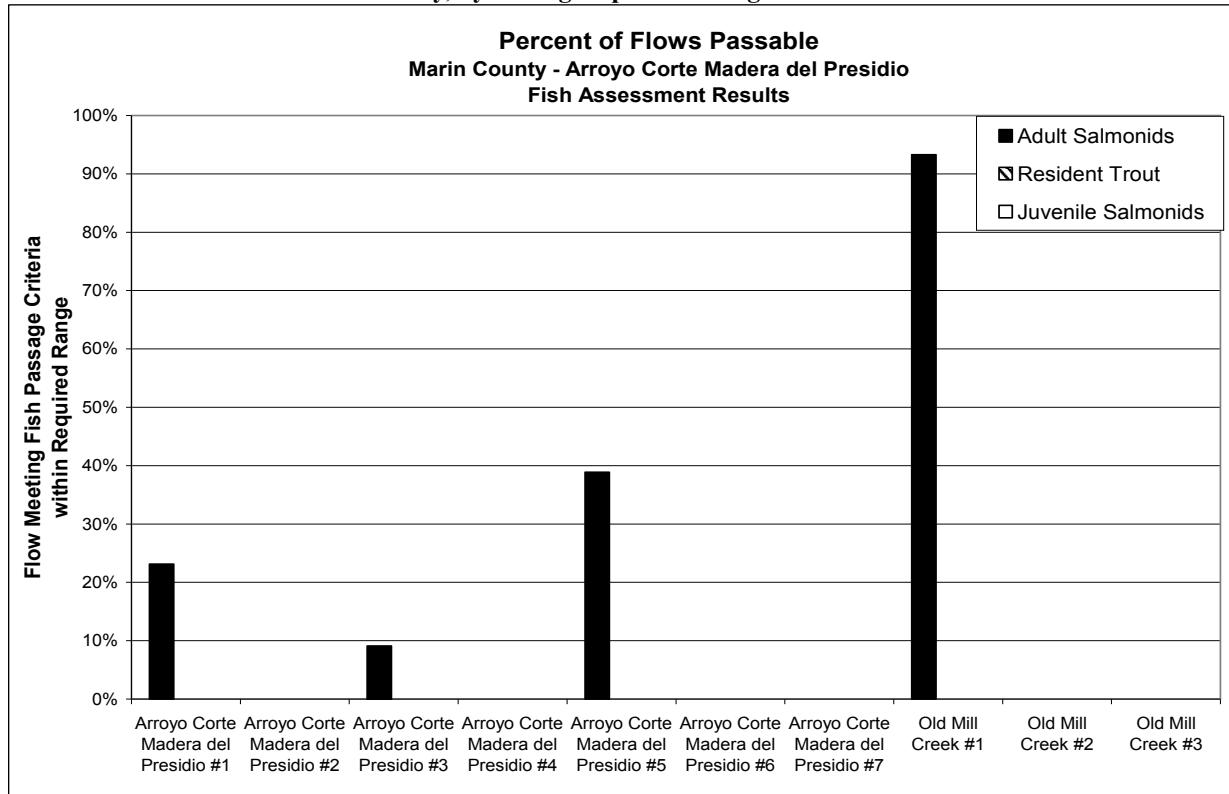
Figure 13. Percent passable as estimated by FishXing for 10 Marin County stream crossings within the Arroyo Corte Madera del Presidio watershed, by three groups of life stages.

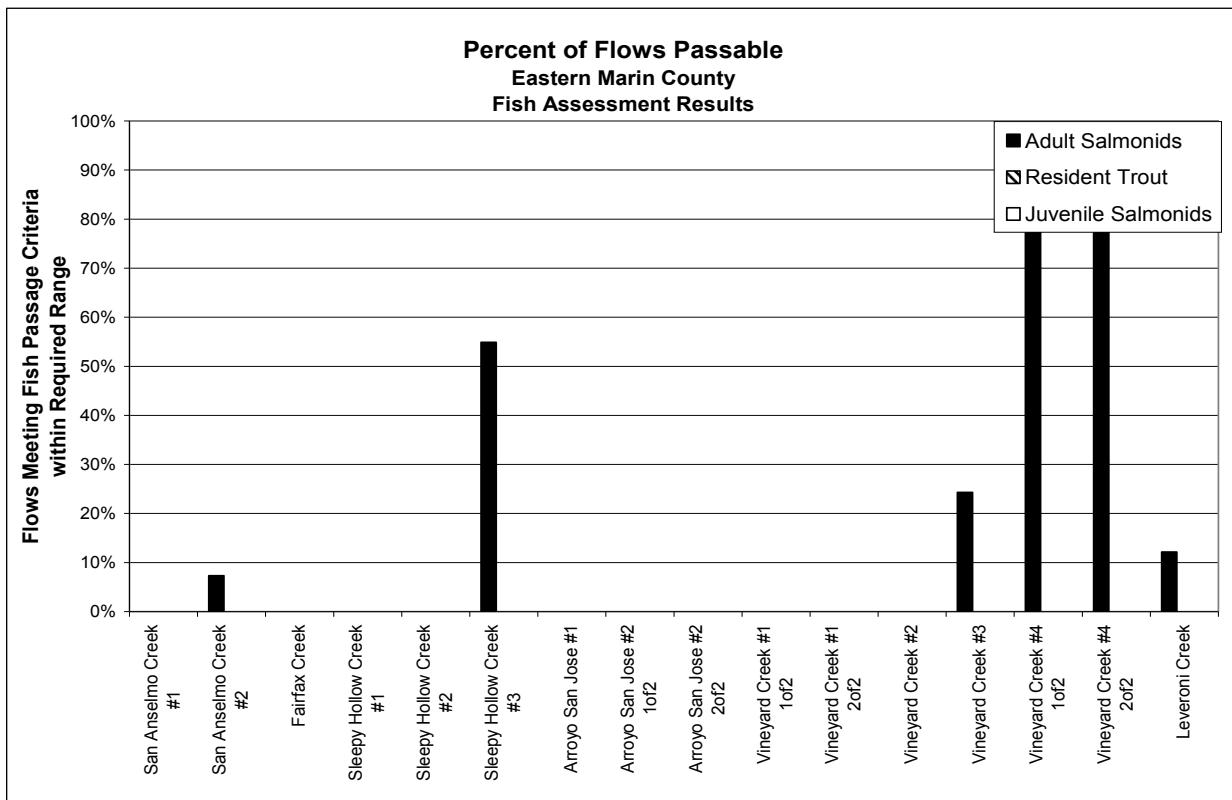
Figure 14. Percent passable as estimated by FishXing for 13 Marin County stream crossings within eastern Marin County watershed, by three groups of life stages.
