# Tech Memo

To: Mill Valley StreamKeepers  
From: Roger Leventhal, P.E., FarWest Restoration Engineering  
Date: December 13, 2004  
Re: Preliminary Fish Barrier Culvert Modifications and Flood Assessment, Arroyo Corte Madera del Presidio and its tributary, Old Mill Creek, Mill Valley, Marin County, California

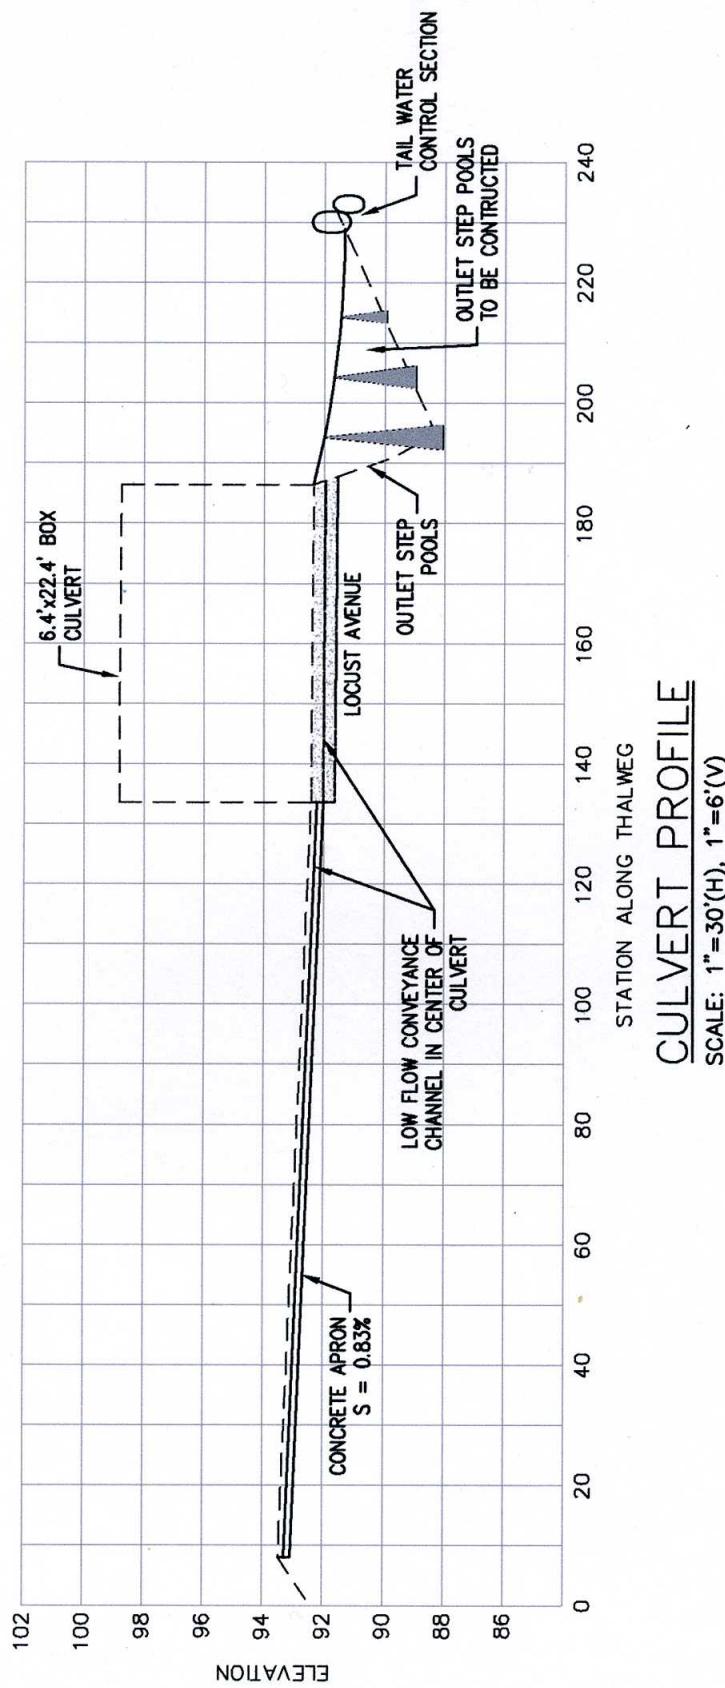
**FIGURE 1**  
**MILL VALLEY FISH BARRIER CULVERT MODIFICATIONS**  
**ARROYO CORTE MADERA DEL PRESIDIO #1**  
**LOCUST AVENUE (MR-068)**

The Arroyo Corte culvert at Locust Avenue is a 6.4 foot high by 22.2 foot wide arch culvert with a concrete bottom that runs under Locust Avenue and also under an apartment building. At the inlet to the culvert, there is also a 125 foot long concrete apron that was included in the fish passage evaluations.

*Adult Steelhead:* Meets criteria for 23% of range of estimated migration flows; fails to meet depth criteria only for flows below 61 cfs (adult flow range is 3 to 78.4 cfs).

- The proposed barrier modification will consist of cutting of the following:
- Demolition and removal of concrete and asphalt to a depth of approximately 18 to 24 inches from a 4 to 10 feet wide channel along the bottom of the structure
- Reinforcement of the channel side slopes with a concrete reinforcement to an assumed depth of three feet (to be confirmed during final design)
- Placement of rock and gravel to provide a natural bottom passageway within the culvert.
- Installation of three log weir at the tailwater section to raise tailwater elevation
- Removal of portions of the upstream asphalt entranceway.

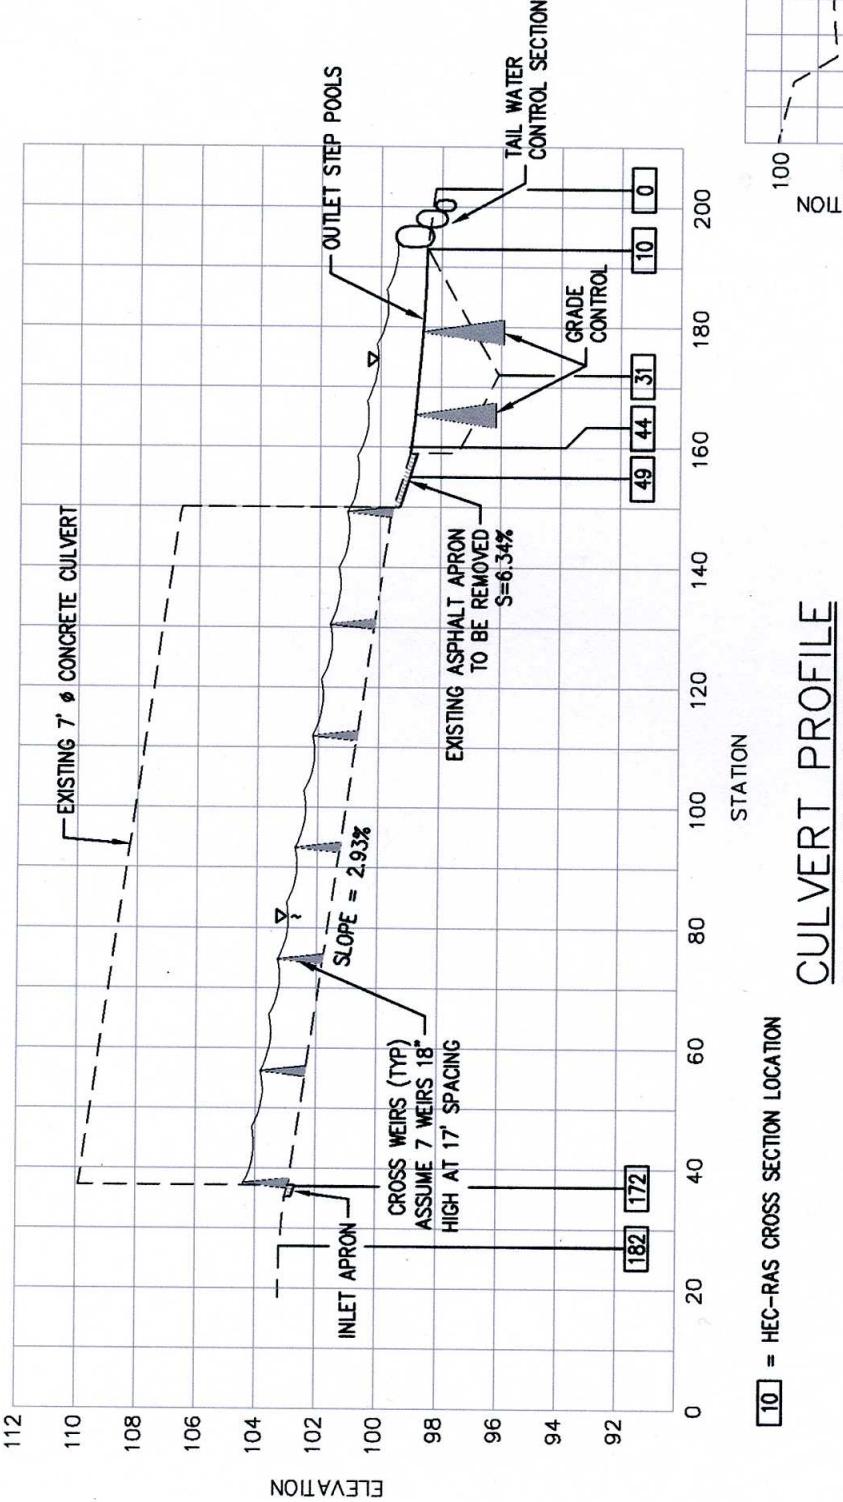
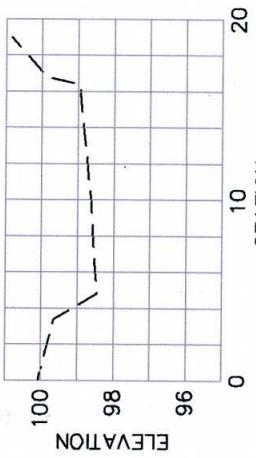
**FIGURE 3**  
**MILL VALLEY FISH BARRIER CULVERT MODIFICATIONS**  
**ARROYO CORTE MADERA DEL PRESIDIO #2**  
**UNDER BUILDING (MR-069)**

This culvert was mapped as a 7 foot diameter 111 foot long concrete culvert at a slope of approximately 2.93 percent. The outlet pool of the culvert is the confluence of Arroyo Corte and Old Mill Creeks.

*Adult Steelhead:* Fails to meet criteria for velocity for flows from 7 cfs to 33.6 cfs (passage flow range of flows is 3 to 33.6 cfs)

In addition, R. Taylor evaluated that the culvert was undersized with an approximate storm capacity of only the 25 year flow event.

The results indicate overtopping of the culvert for both 100-year flow conditions. The increase in water level due to the baffles/pool weir system is approximately 1 to 2 feet. Note that communications with City of Mill Valley staff indicate that upstream culverts at Throckmorton and Sunnyside may have more significant existing flooding impacts, thereby reducing the flood flows to MR-069.

Therefore, construction of a pool-weir fishway within the culvert may be required to achieve passage goals. In addition, tailwater elevations will be raised by construction of a series of downstream log sills to raise the tailwater condition. Given that passage of juvenile salmonids is required, the step height of the proposed pool-weir fishway will be limited to 0.5 feet. The step culvert section helps achieve pool volumes to dampen turbulence but these design elements will have to be evaluated during the subsequent design phase of the project. Figure 3 shows the existing culvert and proposed modifications.

For analysis purposes, it was assumed that a pool weir fishway will be constructed in the culvert with step 18 inches high at spacing of approximately 8 feet for a total number of steps of approximately fourteen. This baffle weir will provide a pool depth of approximately one foot or twice the 0.5 foot step height.

- Construction of a downstream tailwater pool steps to raise elevations 1-2 feet.

- Install a series of weirs and pool cross-baffles to reduce velocities and increase depths to meet guidelines; or make recommendations for barrier replacement. Figure 7 shows a typical baffle expansion ring taken from the State of Washington Department of Fish and Wildlife manual.
- Install upstream berms or flood proofing to contain channel breakout flows.

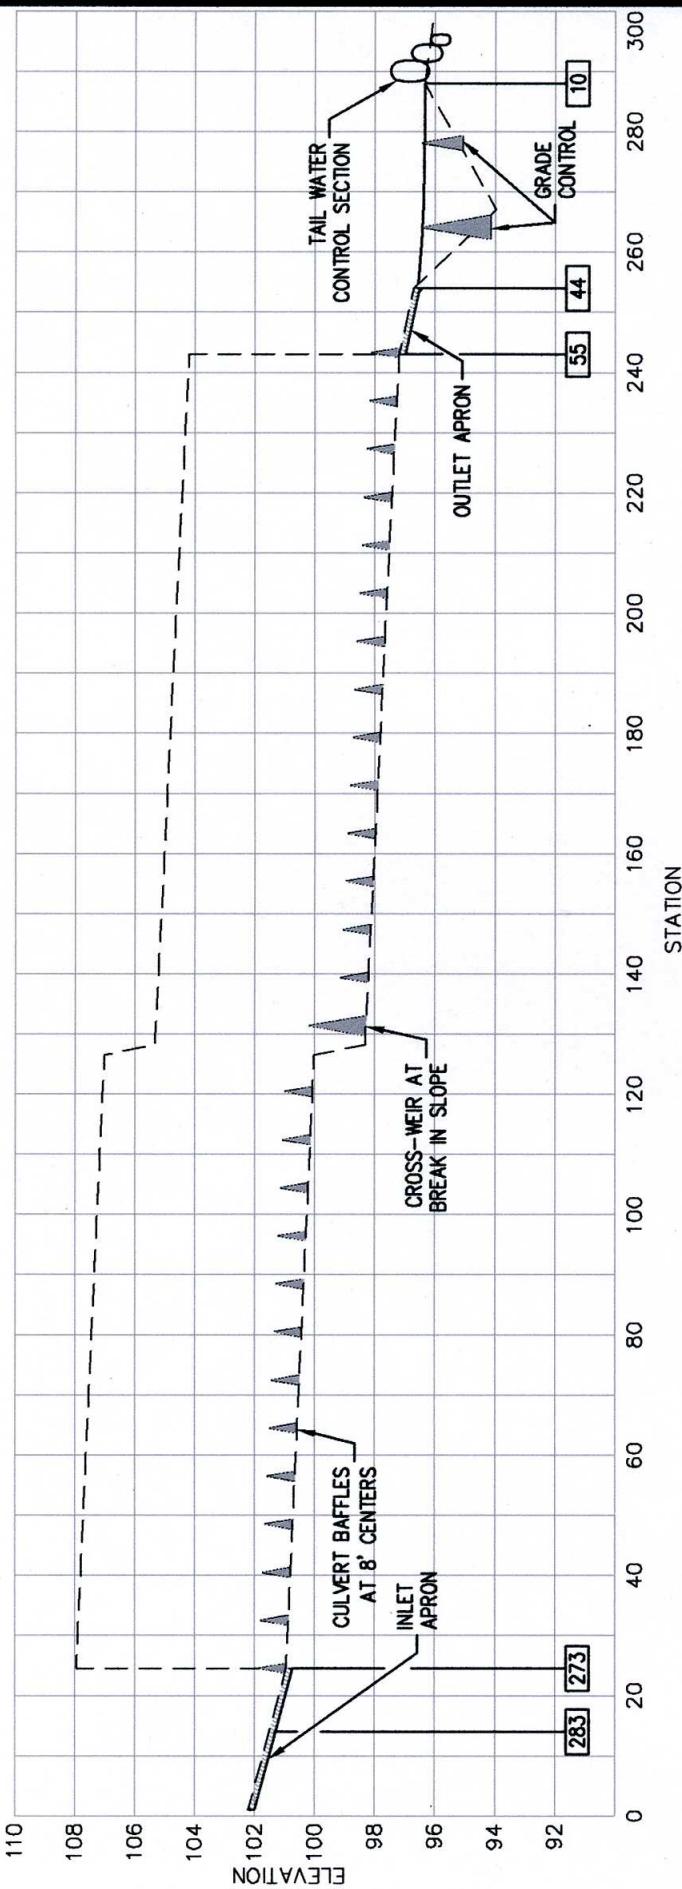
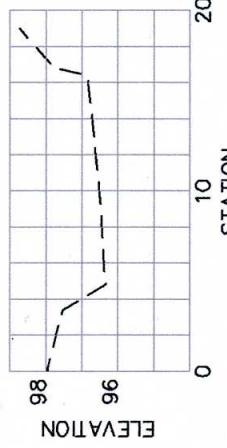
**FIGURE 4  
MILL VALLEY FISH BARRIER CULVERT MODIFICATIONS  
OLD MILL CREEK #1  
MILLER AVENUE (MR-075)**

The MR-075 culvert is located along Old Mill Creek under Miller Avenue right through downtown Mill Valley. The culvert is 218.5 feet long at a diameter of 7 feet and is laid at an overall slope of 1.72 percent (Figure 4). There is a break in slope halfway through the culvert. The outlet pool of the culvert is the confluence of Arroyo Corte #2 (MR-069).

*Adult Steelhead:* Fails to meet criteria for velocity for flows from 5.5 cfs to 20 cfs (passage range of flows is 3 to 40.3 cfs)

In addition, R. Taylor evaluated that the culvert was undersized with an approximate storm capacity (HW/D=1) of only the 14 year flow event. Taylor estimated that Miller Avenue is overtopped on a 92-year storm event.

A first-cut culvert analysis using HY-8 shows that at a flow of 40.3 cfs (the one percent upper passage flow) the velocity through the culvert is approximately 11 ft/sec, well above the design guidelines of 3-4 ft/sec described above for adult salmonids in a culvert over 200 feet.

The results indicate overtopping of the culvert for both 100-year flow conditions.

For analysis purposes, it was assumed that baffles will be constructed in the culvert with step 12 inches high at a spacing of approximately 1.2 times the culvert diameter (DFG guidance criteria) for a total number of steps of approximately 30.

- The proposed barrier modification will consist of cutting of the following:
- Construction of a downstream tailwater pool steps to raise elevations one to two feet.
- Evaluate the effectiveness of installing corner baffles or if required a series of step-pool weirs to reduce velocities to meet guidelines.
- Install berms or floodwalls along those areas of the creek identified during final hydraulic analysis as showing overbank flooding.
