Fish Passage Improvement

Old Mill Creek at Cascade Drive Bridge Culvert in Old Mill Park

Mill Valley, CA

January 2023

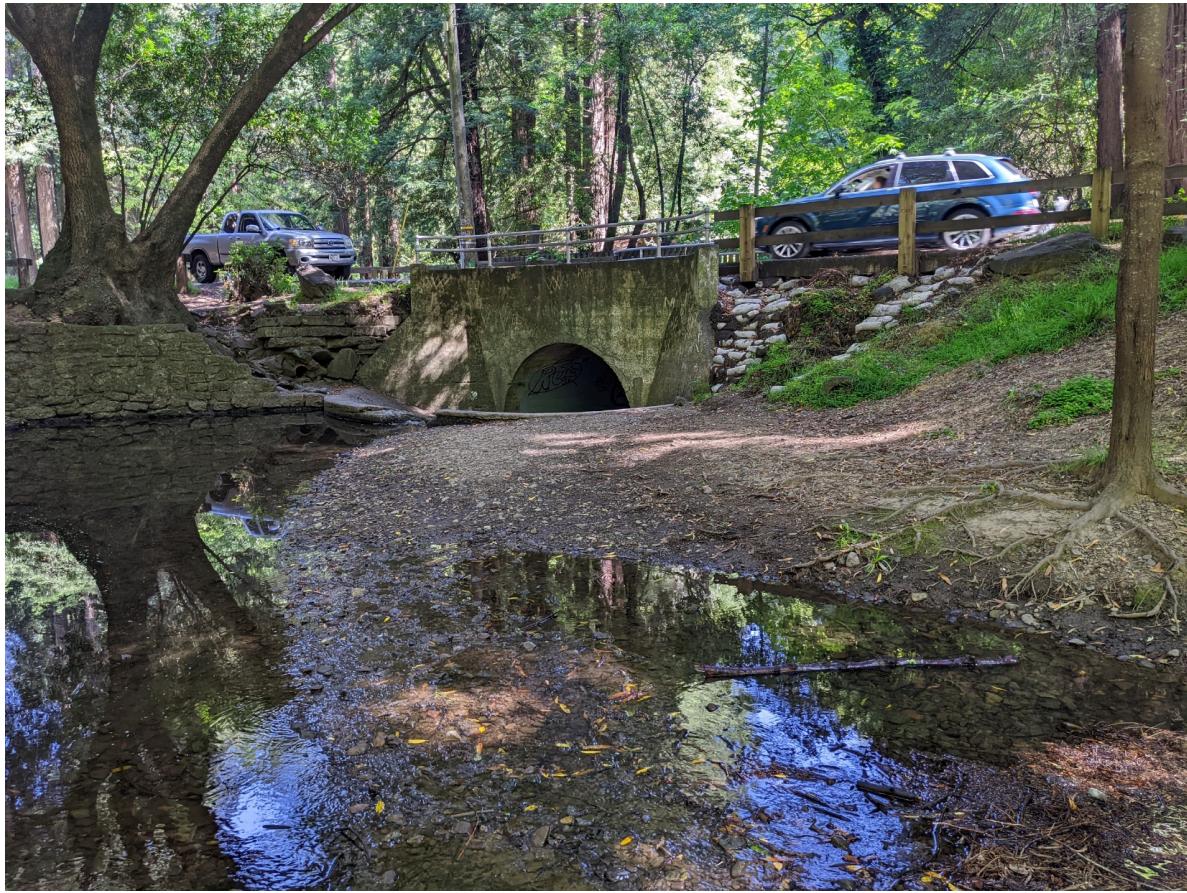
Looking downstream to Cascade Drive Bridge Culvert in Old Mill Park (June 15, 2022).

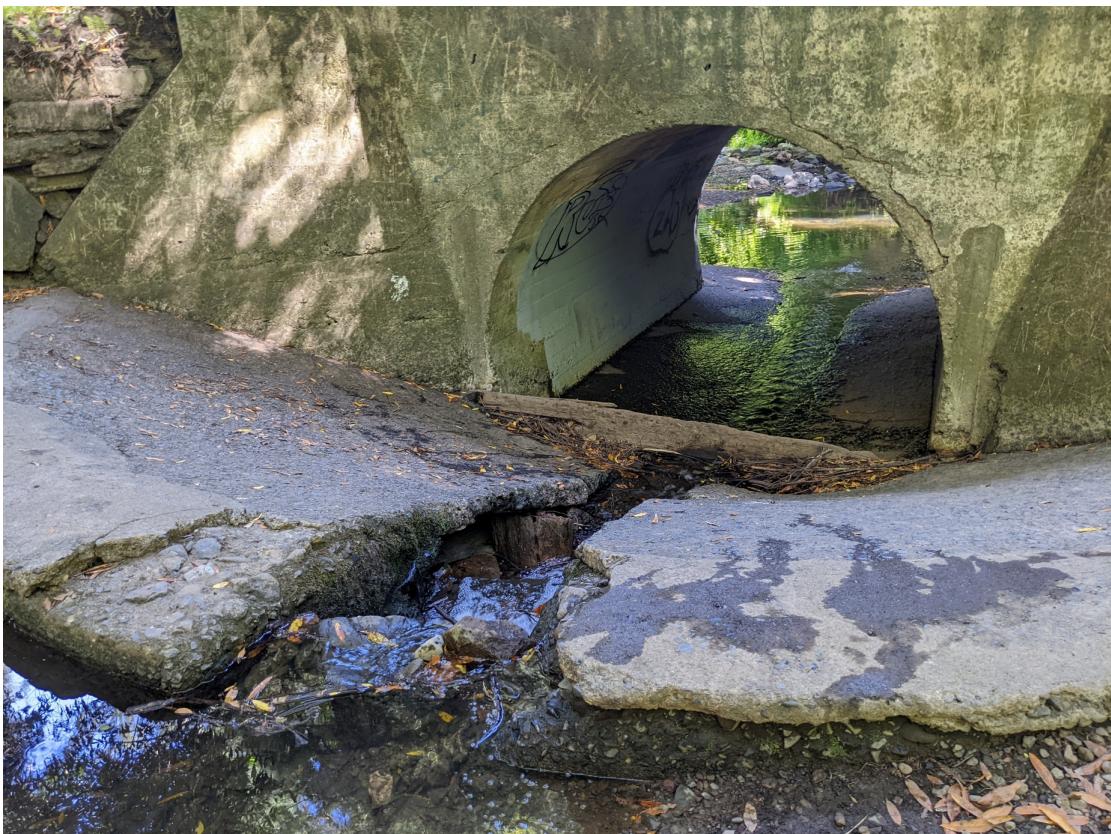
Looking downstream from top of concrete-covered fill apron through the culvert barrel (June 15, 2022).

The existing concrete arch culvert opening is an approximately 9.5-ft-diameter circle with a gradual v-shaped concrete-filled invert making the opening height approximately 8.5 ft. The concrete floor slopes approximately 5% downstream, and spills over the sloped apron downstream from the outlet with a short fall directly into a plunge pool with scattered loose boulder rip-rap on the bed. Extending downstream from the culvert, the channel bed and banks are covered with boulder rip-rap. There are at least two buried redwood logs exposed on the bed about 100 feet downstream from the culvert. There is steeply-sloped concrete apron immediately upstream from the culvert inlet. The apron creates a spillway. Summer low flows pond up to the spillway crest elevation.

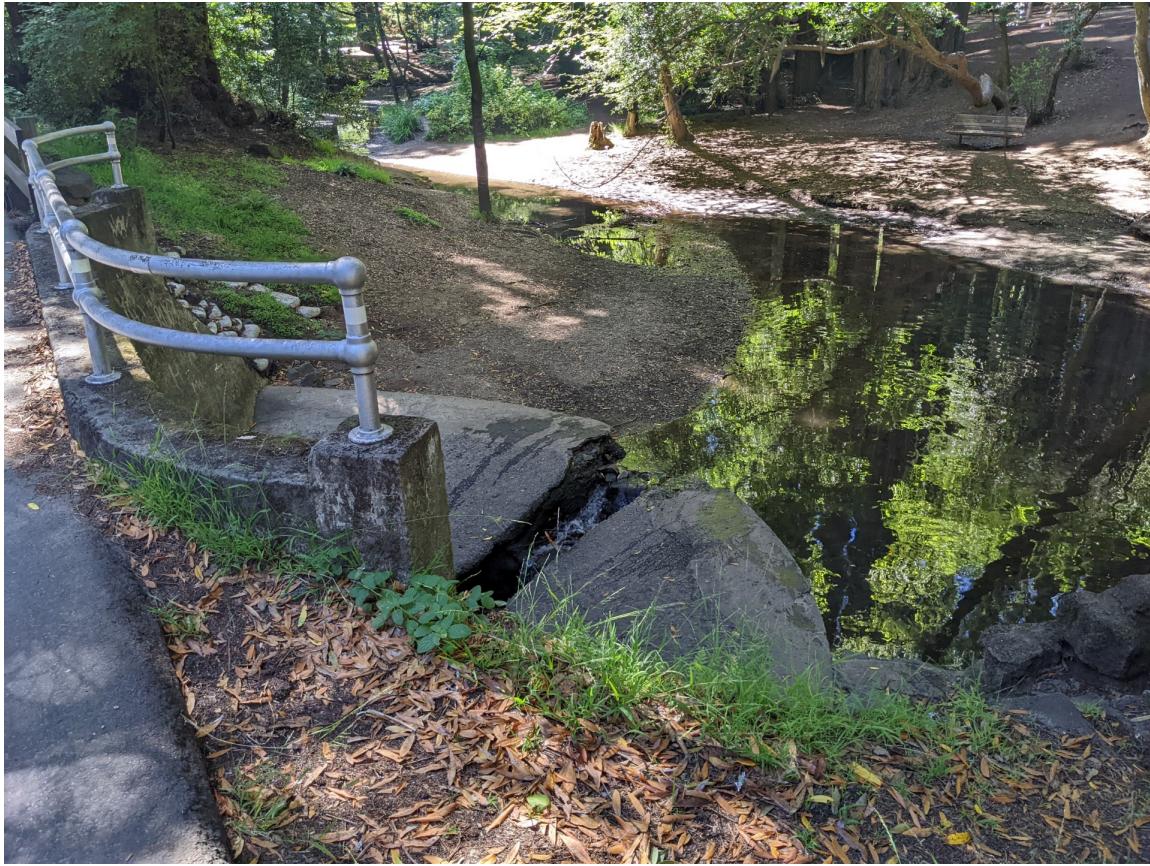
The concrete-covered apron on the upstream side of the bridge is in failing condition. Old Mill Creek low-flows spill through a narrow approximately 3-ft-wide slot cut through part of the thickness of apron materials: a 3-4"-thick top layer of newer concrete, covering a massive thickness of what appears to be poor quality concrete or asphalt concrete fill placed within a historical timber structure, including tops of vertical timber piling, possibly remnants of a pre-1911 road crossing, and/or a low-head dam associated with the 1830s sawmill 250 ft downstream. Structurally, the apron structure can be likened to a concrete-faced concrete filled timber crib dam, with unknown foundation supported by almost 200-year-old timber piers of unknown depth and spacing. There are also exposed redwood logs near the recreated historical mill structure, which may be remnants of a timber-cribbing reinforced channel.

The material beneath the newer concrete cover is lower strength and in places within the length of the apron flow line that underlying material has eroded to undermine the concrete cover layer laterally by 4-6 or more horizontal feet. The apron crest forming the upstream pool tail-out has down-cut approximately 9 inches – through the entire top layer of newer concrete and several more inches into the older low quality concrete fill.

Looking upstream from Cascade Way roadway to creek and failing concrete-covered apron (June 15, 2022).

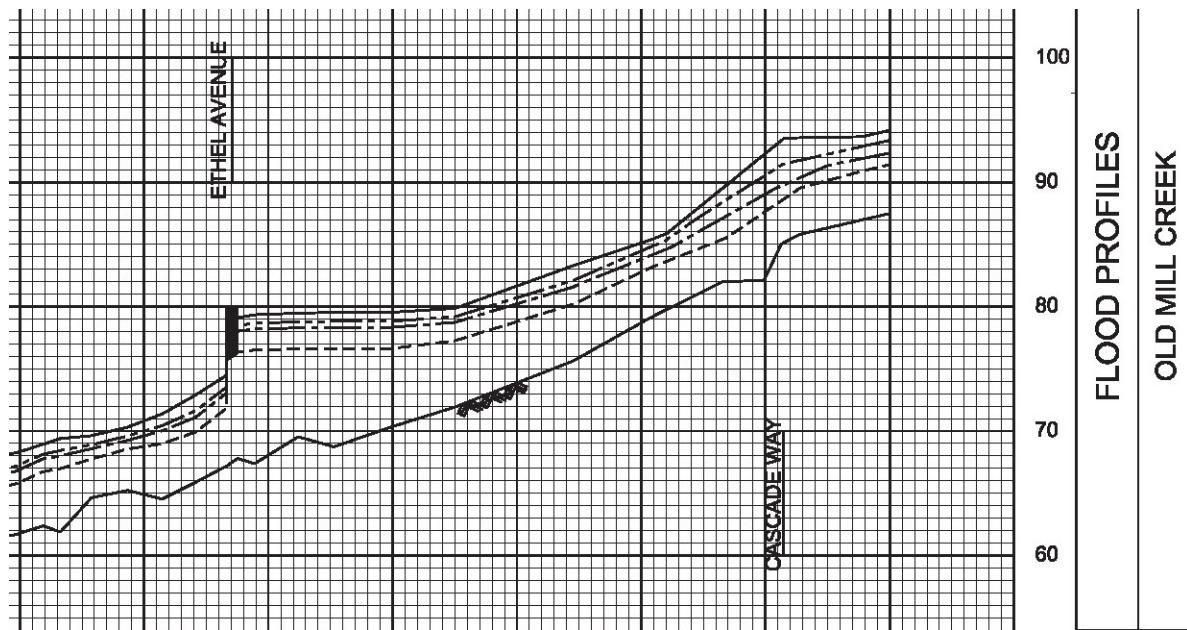
Figure 3. FEMA Flood Insurance Study published flood flow water surface elevation profiles at the Cascade Way Bridge/Culvert Crossing. The 100-year peak water surface elevation is about 91.5 feet at the culvert inlet – about 6" below the top of the arch culvert rise (ceiling).

According to preliminary hydrology and hydraulic evaluation, the existing culvert is adequately sized for passing the 100-year peak flows but would not provide adequate freeboard for passing debris. Under temporary stabilized conditions (with the barrel diameter and ceiling elevation reduced by 6" thick steel-reinforced concrete cladding, the 100-year peak flow upstream water surface elevation would be expected to rise as much as 1 vertical foot upstream, but it does not appear that this would cause overbank flooding or damage to property. There is not a FEMA regulatory floodway on Old Mill Creek.

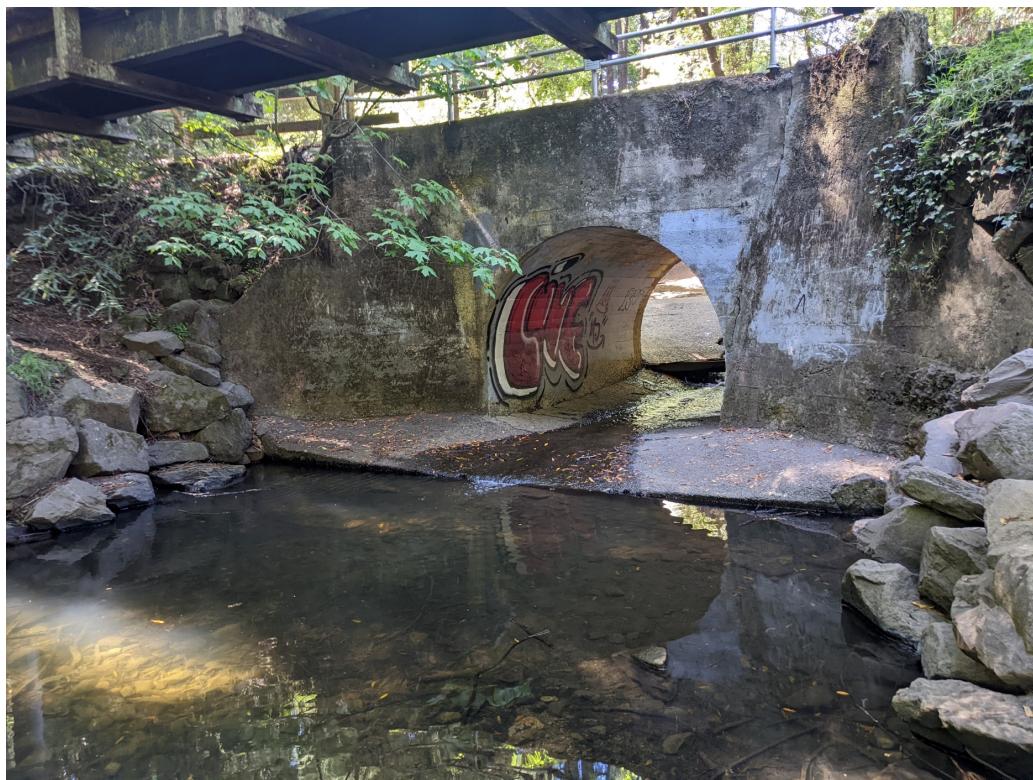
Looking upstream to culvert outfall with sloped concrete apron and plunge pool (June 15, 2022).

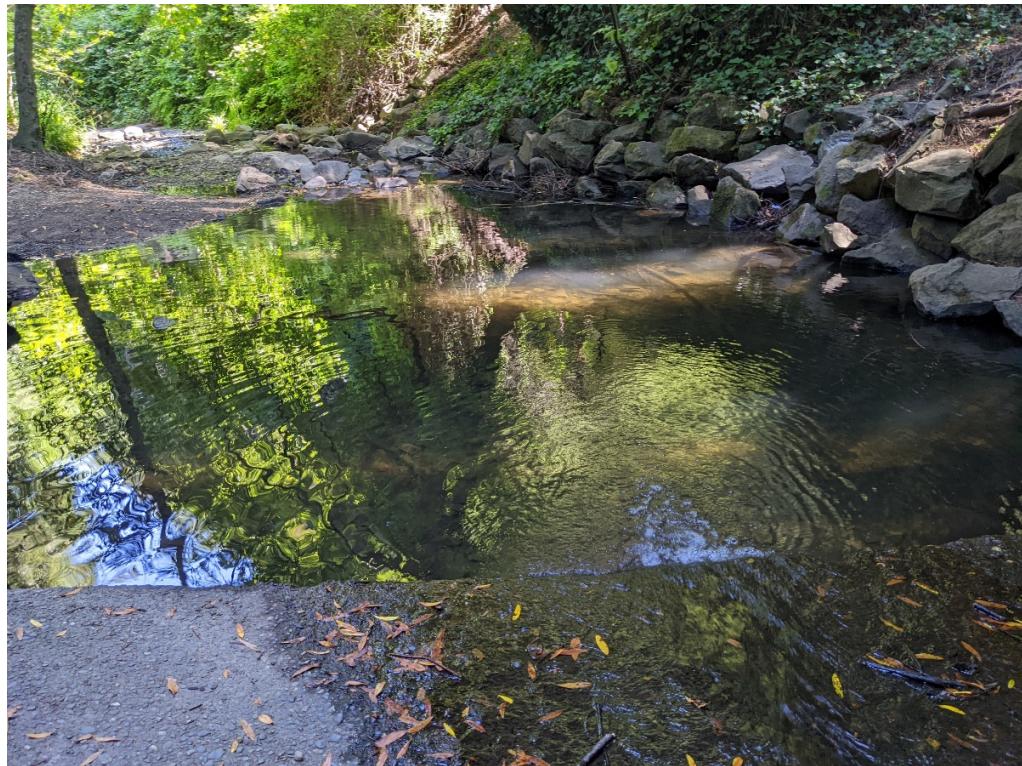
Looking downstream to the plunge pool and rip-rap dominated pool tail-out (June 15, 2022).

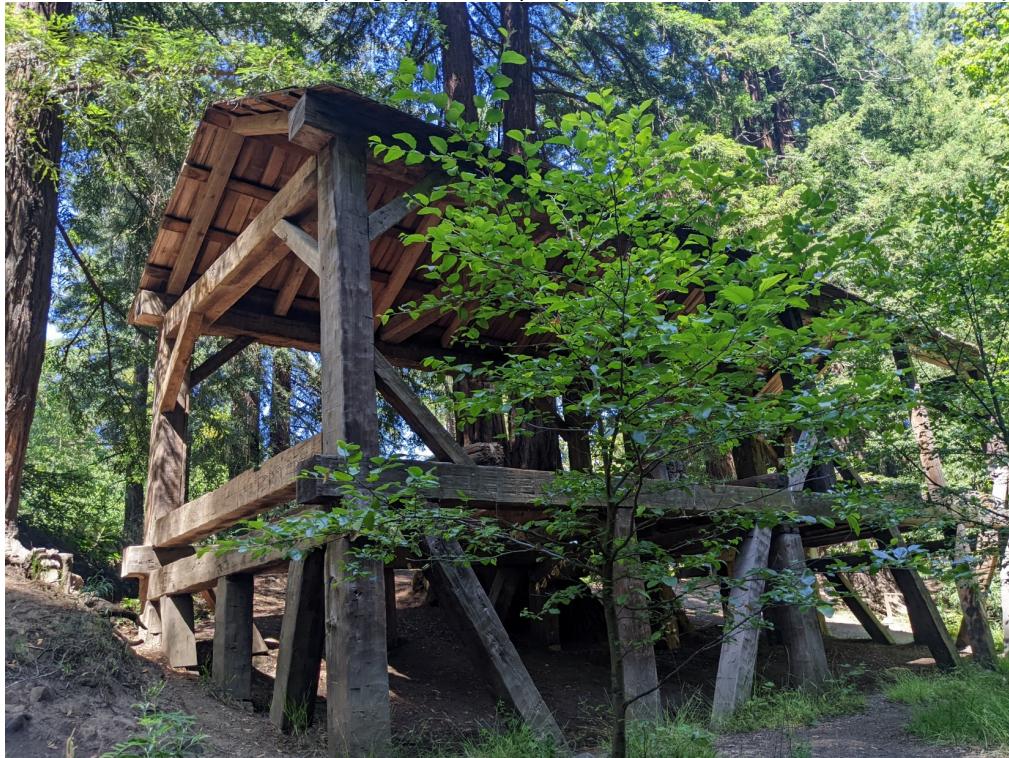
Looking to left bank at saw mill structure close to the channel (June 15, 2022).

About 110 feet downstream from the culvert apron outfall there is a recreated historical saw mill structure on the left bank very close to the channel. The narrowest channel cross-section occurs at the upstream end of the saw mill structure. The right bank is a very steep invasive vegetation covered rip-rap slope below the Molina Avenue roadway. Another 80 feet downstream there is a historical concrete flash-board dam that has a minor or negligible effect on channel bed elevations.

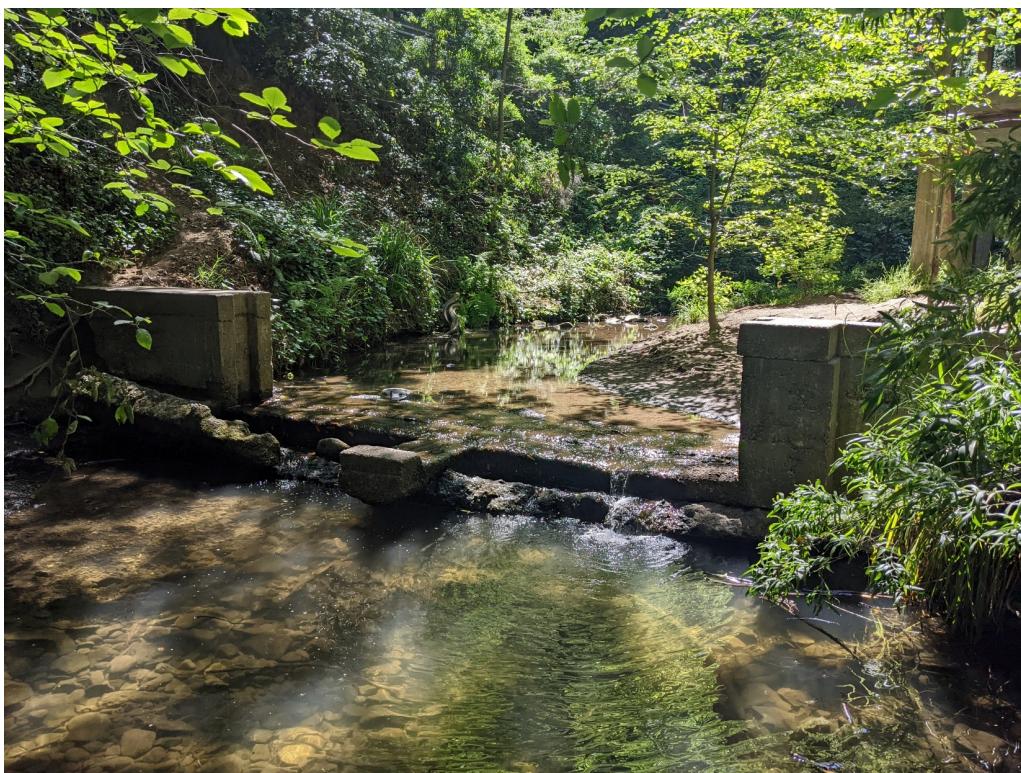
Looking upstream to the concrete flash-board dam. Mill structure in background (June 15, 2022).
