**California Department of Fish and Game  
San Francisco Bay East Marin Watersheds  
Stream Habitat Assessment Reports**

**Arroyo Corte Madera  
del Presidio**

## STREAM INVENTORY REPORT

*Survey Conducted Summer 2009*

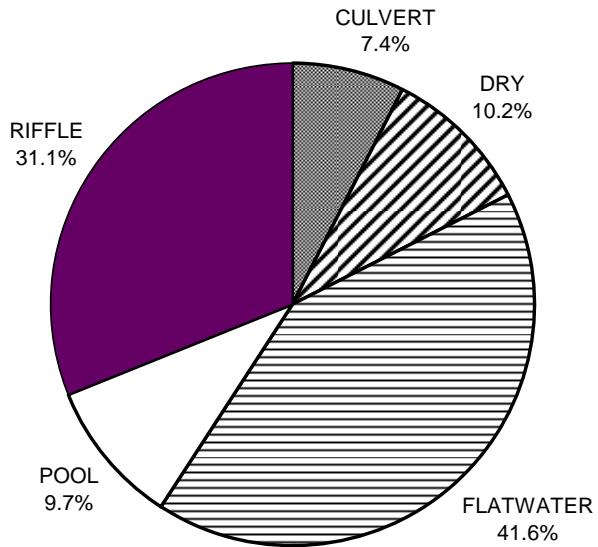
GRAPH 2

Table 1 summarizes the Level II riffle, flatwater, and pool habitat types. Based on frequency of occurrence there were 34% flatwater units, 15% pool units, 29% riffle units, 17% culvert units, and 5% dry units (Graph 1). Based on total length of Level II habitat types there were 42% flatwater units, 10% pool units, 31% riffle units, 7% culvert units, and 10% dry units (Graph 2).

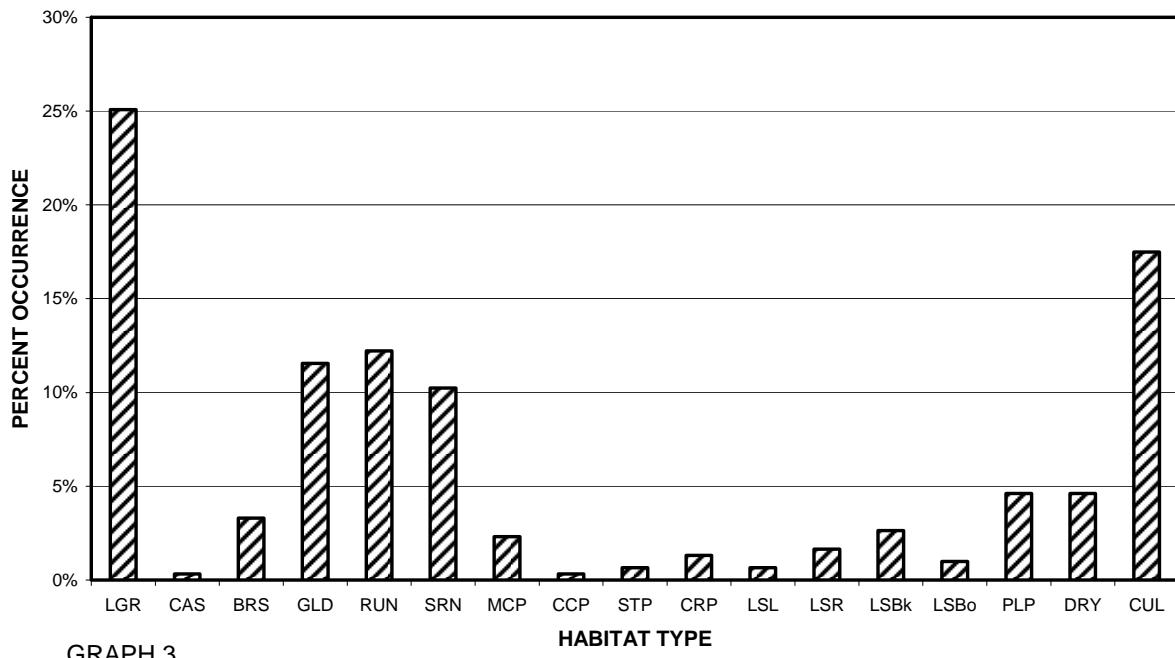
GRAPH 3

percent occurrence were 12% Glide units, 25% Low Gradient Riffle units, 17% Culvert units, and 12% Run units (Graph 3). Based on percent total length the stream was comprised of 21% Step Run units, 28% Low Gradient Riffle units, and 12% Run units.

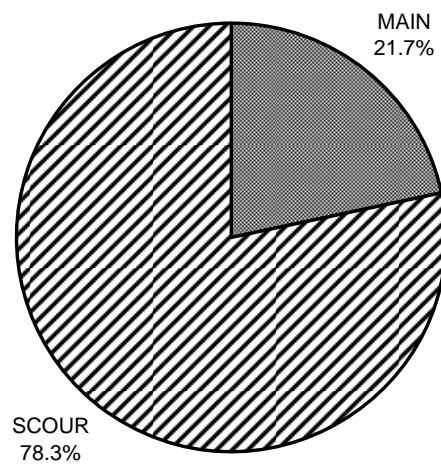
GRAPH 4

A total of 46 pools were identified (Table 3). Scour pools were the most frequently encountered, at 78%, and comprised 74% of the total length of all pools (Graph 4).

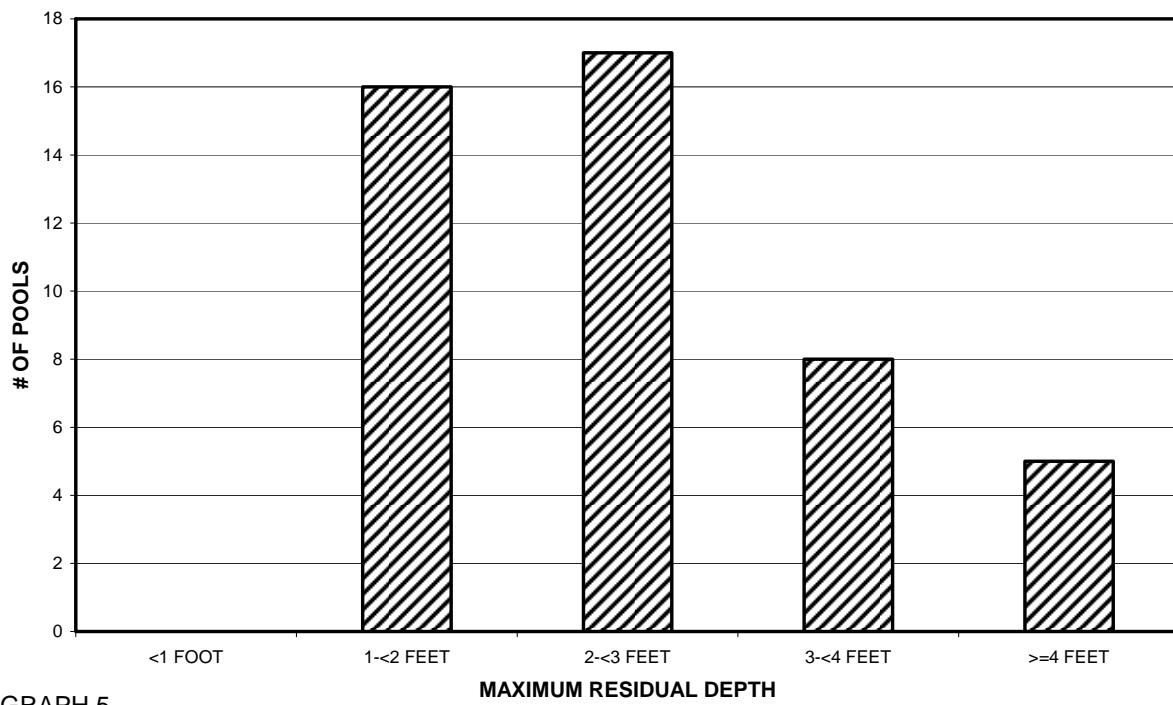
GRAPH 5

Table 4 is a summary of maximum residual pool depths by pool habitat types. Pool quality for salmonids increases with depth. Thirty of the 46 pools (65%) had a residual depth of two feet or greater (Graph 5).

Flatwater habitat types comprised 42% of the total length of this survey, riffles 31%, and pools 10%. The pools are relatively deep, with 30 of the 46 (65%) pools having a maximum residual depth greater than 2 feet. In general, pool enhancement projects are considered when primary pools comprise less than 40% of the length of total stream habitat. In first and second order streams, a primary pool is defined to have a maximum residual depth of at least two feet, occupy at least half the width of the low flow channel, and be as long as the low flow channel width.

Installing structures that will increase or deepen pool habitat is recommended for locations where their installation will not be threatened by high stream energy, or where their installation will not conflict with the modification of any log debris accumulations (LDA's) in the stream.

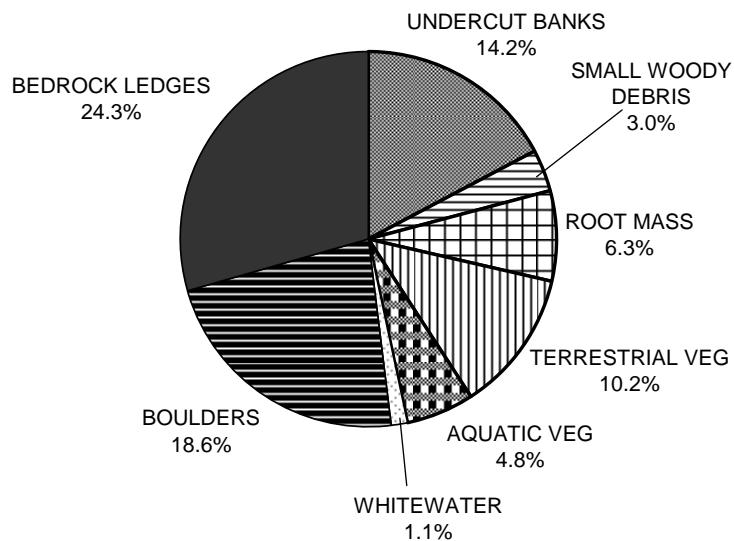
GRAPH 7

Table 5 summarizes mean percent cover by habitat type. Bedrock Ledges are the dominant cover types in Arroyo Corte Madera del Presidio. Graph 7 describes the pool cover in Arroyo Corte Madera del Presidio. Bedrock Ledges are the dominant pool cover type followed by boulders.

The mean shelter rating for pools was 17. The shelter rating in the flatwater habitats was 6. A pool shelter rating of approximately 100 is desirable. The amount of cover that now exists is being provided primarily by Bedrock Ledges in Arroyo Corte Madera del Presidio. Bedrock Ledges are the dominant cover type in pools followed by boulders. Log and root wad cover structures in the pool and flatwater habitats would enhance both summer and winter salmonid habitat. Log cover structure provides rearing fry with protection from predation, rest from water velocity, and also divides territorial units to reduce density related competition.

- 2) Increase woody cover in the pools and flatwater habitat units. Most of the existing cover in the pools is from Boulders. Adding high quality complexity with woody cover in the pools is desirable.

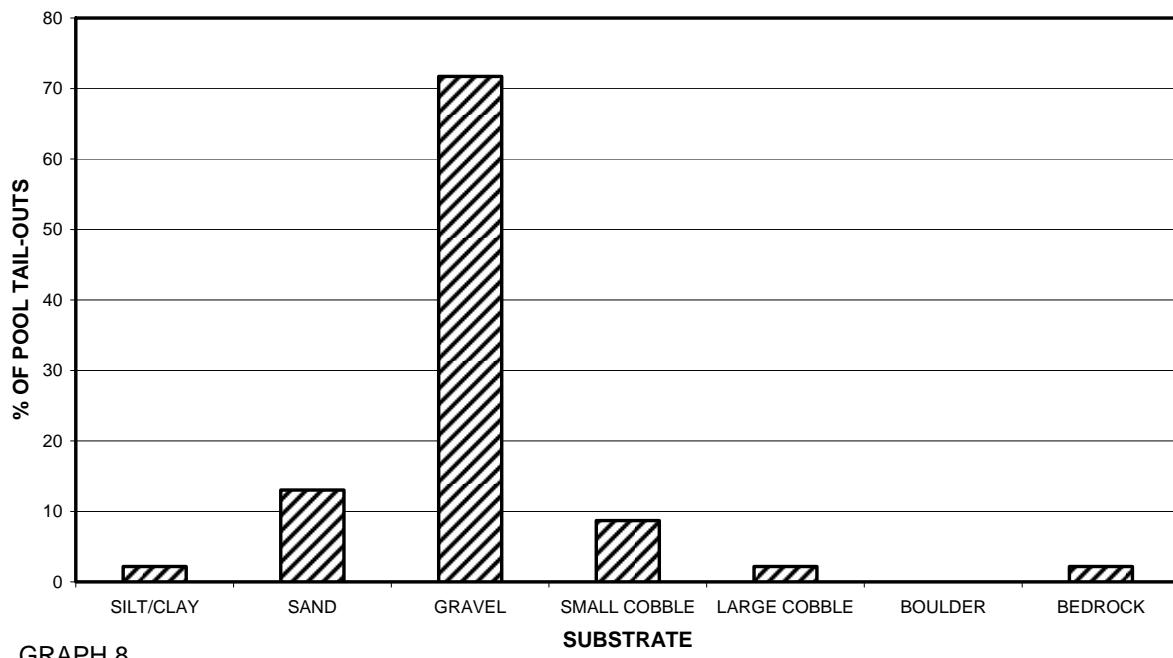
GRAPH 8

Table 6 summarizes the dominant substrate by habitat type. Graph 8 depicts the dominant substrate observed in pool tail-outs. Sand dominance was observed in 13% of pool tail-outs, and gravel dominance was observed in 72% of pool tail-outs.

Thirty-seven of the 46 pool tail-outs measured had gravel or small cobble as the dominant substrate. This is generally considered good for spawning salmonids.

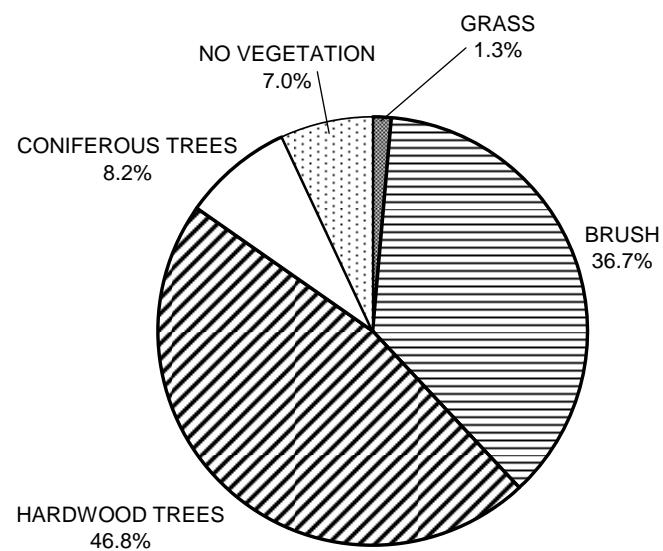
GRAPH 11

For the stream reach surveyed, the mean percent right bank vegetated was 57%. The mean percent left bank vegetated was 50%. The dominant elements composing the structure of the stream banks consisted of 39% bedrock, 8% boulder, 8% cobble/gravel, and 44% sand/silt/clay (Graph 10). Hardwood trees were the dominant vegetation type observed in 47% of the units surveyed. Additionally, 37% of the units surveyed had brush as the dominant vegetation type, and 8% had coniferous trees as the dominant vegetation (Graph 11).

The percentage of right and left bank covered with vegetation was 57% and 50%, respectively. In areas of stream bank erosion or where bank vegetation is sparse, planting endemic species of coniferous and hardwood trees, in conjunction with bank stabilization, is recommended.

- 4) Increase the canopy on Arroyo Corte Madera del Presidio Creek by planting appropriate native vegetation like willow, alder, redwood, and Douglas fir along the stream where shade canopy is not at acceptable levels. The reaches above this survey section should be inventoried and treated as well, since the water flowing here is affected from upstream. In many cases, planting will need to be coordinated to follow bank stabilization or upslope erosion control projects.
