# Tech Memo

To: Mill Valley StreamKeepers  
From: Roger Leventhal, P.E., FarWest Restoration Engineering  
Date: December 13, 2004  
Re: Preliminary Fish Barrier Culvert Modifications and Flood Assessment, Arroyo Corte Madera del Presidio and its tributary, Old Mill Creek, Mill Valley, Marin County, California

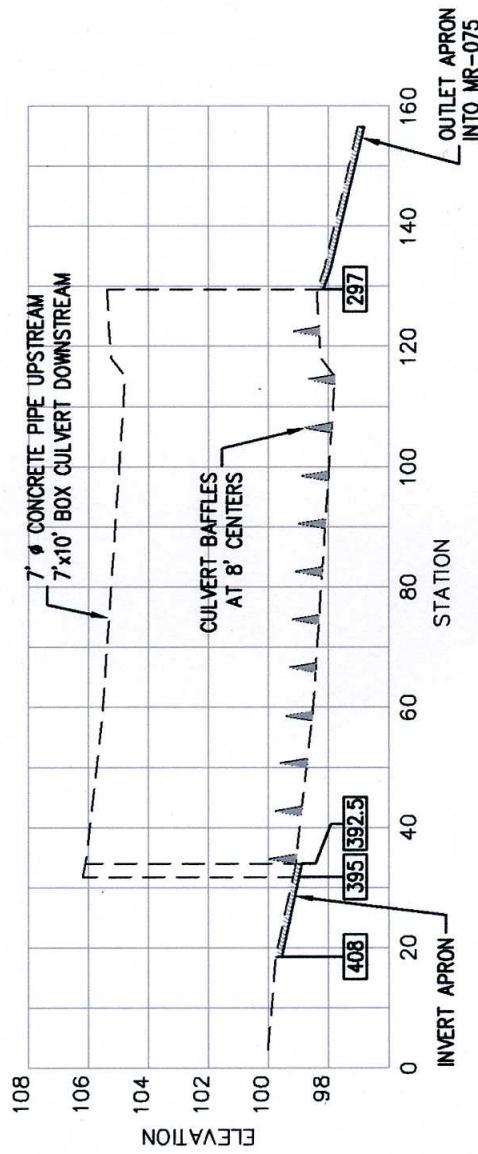
**FIGURE 4  
MILL VALLEY FISH BARRIER CULVERT MODIFICATIONS  
OLD MILL CREEK #1  
MILLER AVENUE (MR-075)**

The MR-075 culvert is located along Old Mill Creek under Miller Avenue right through downtown Mill Valley. The culvert is 218.5 feet long at a diameter of 7 feet and is laid at an overall slope of 1.72 percent (Figure 4). There is a break in slope halfway through the culvert. The outlet pool of the culvert is the confluence of Arroyo Corte #2 (MR-069).

*Adult Steelhead:* Fails to meet passage criteria for velocity and depth.

The results indicate overtopping of the culvert for both 100-year flow conditions. The anticipated rise in water level was calculated to be approximately 0.6 to 3 feet from existing water levels under flood conditions.
